Monitoring Data RecordProject Title: R-2206B (NC 16 Bypass) COE Action ID: 200431320Stream Name: UT to Forney Creek (Site 10B) WQC Number: 3476City, County and other Location Information: Lincoln County, NC 16 Bypass
(Sta. 159+00 LT.-L-)Date Construction Completed: 3-3-08 Monitoring Year: (1) of 5Ecoregion: _____ 8 digit HUC unit 03050101

UT Forney Creek

Year 1 Winter – March 2008

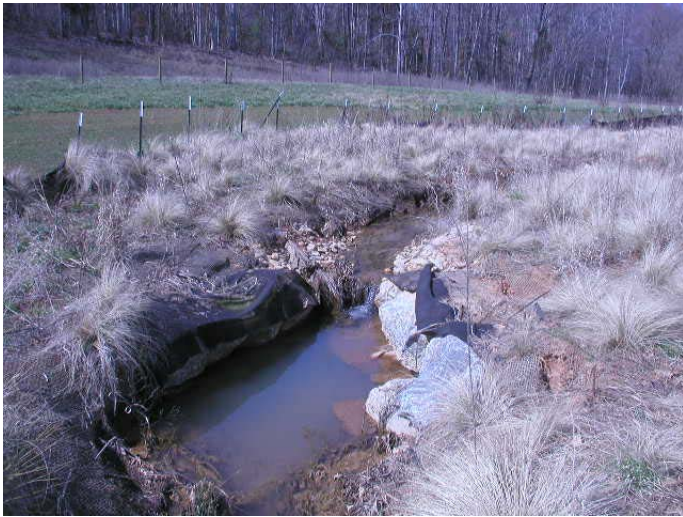
Photo Point #5 (Upstream)

UT to Forney Creek has some bank erosion behind the left arm of a crossvane at Photo Point #5 (Upstream). Other than this minor erosion the stream is in fairly stable condition for Year 1 Winter evaluation.

Date 3/3/08	PP#5 (Upstream)	Station Number	Station Number	Station Number	Station Number
Structure Type	Crossvane				
Is water piping through or around structure?					
Head cut or down cut present?					
Bank or scour erosion present?	Minor erosion behind left arm of crossvane				
Other problems noted?
